# Polesight Project Final Report

Prepared for: Northern Powergrid

Report No: EA9744

Date: 22<sup>nd</sup> of March 2024

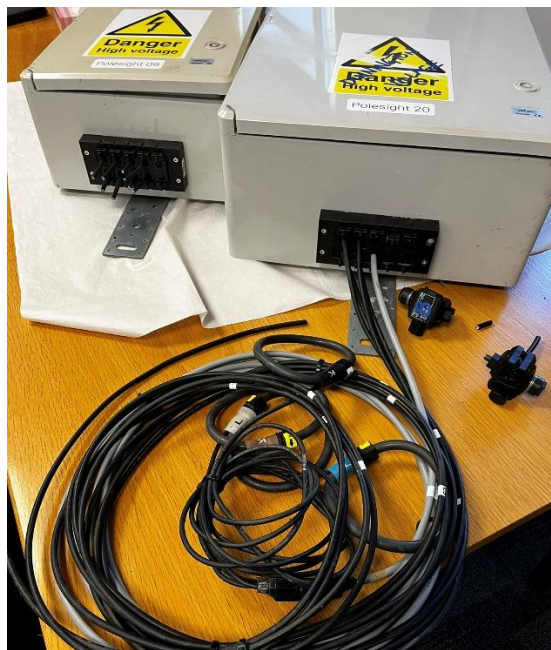
Figure 12 Polesight 09 and 20, post removal

As can be seen from Figure 12, Polesight 09 had all connection wires cut when removed. There was no information provided about the ease of removal as the transformer being dead allowed the contractor to remove the device without disconnecting the cables. No condition assessment could therefore be performed on the cables, connectors, or coils; however, the box and the cable glands were intact and showed minimal signs of wear and tear.

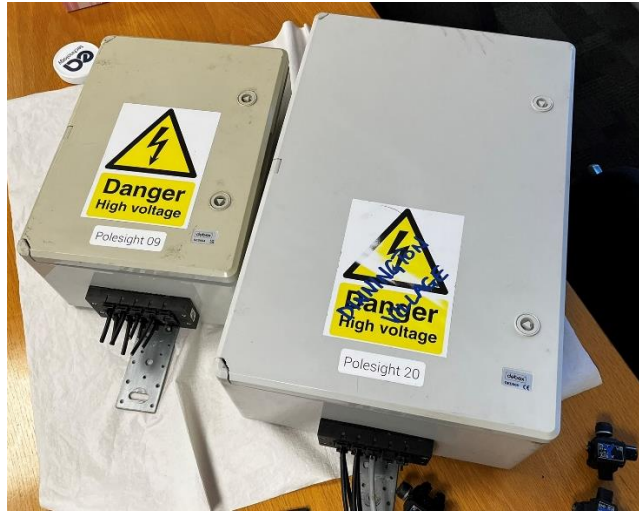
Figure 13 Difference in discolouration of devices

happened in transit as the scrape continued across the front of the enclosure door and looks more like a friction rub than possible UV damage.

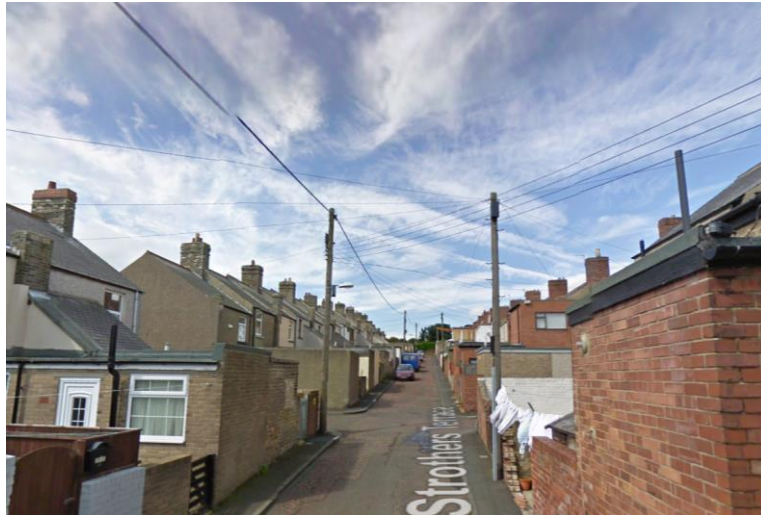
This location seemed the most likely out of the three determined due to the number of opportunities for joint or other asset breakdowns.

The benefit of looking for evidence of an OHL PreFault is that the possible branches are visible by a pedestrian. In this location, since the impedance indicated the PreFault was somewhere around the pole, it could be that the service to one of the domestic properties was the source of the PreFault. It is not uncommon that service faults are identified by monitoring as there is no way to discern between the mainline and a service until a fault has occurred.

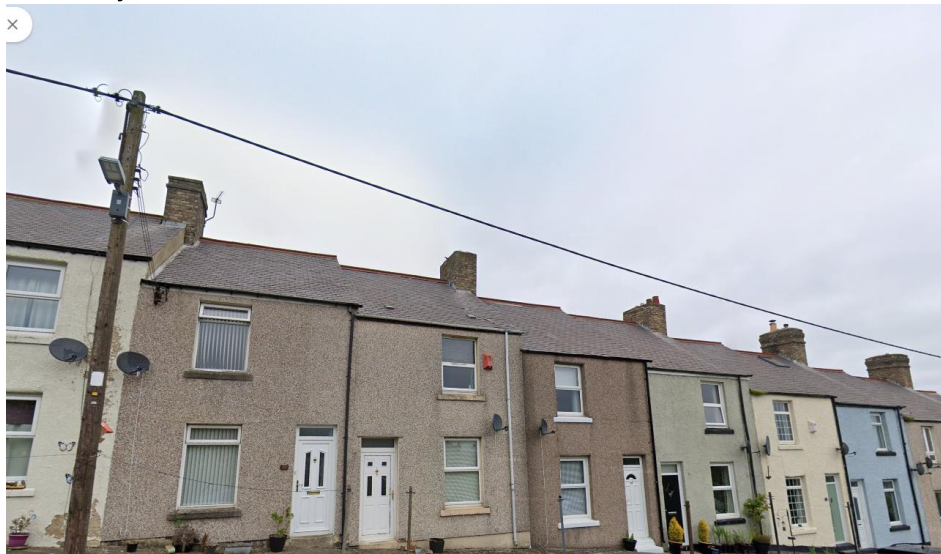
#### 1<sup>st</sup> Event Location 2: Clayton Terrace Road, in front of houses

Nothing of note can be highlighted at this location to determine where the PreFault could be located. Like the previous example it could be located on a service or there could have been an event at the pole. Without a related fault this is speculative.

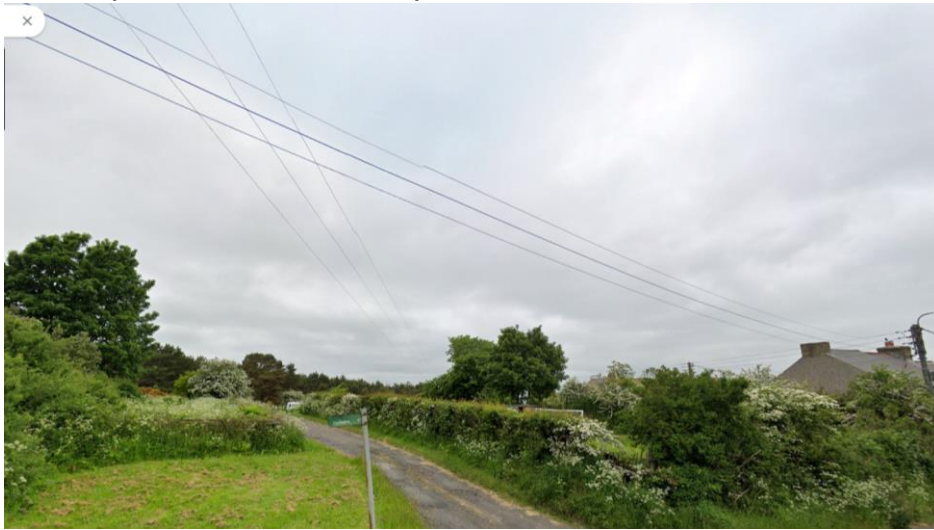
### 1<sup>st</sup> Event Location 3: Clayton Terrace Road, above junction

Like the other Clayton Terrace Road location there is nothing that immediately suggests the location of the PreFault. However, the line being hard drawn bare copper (HDBC) could suggest that the transient PreFault was the result of clashing conductors. This was a hypothesis provided at the time of the event but further evidence from other events suggest that this is not the cause of this PreFault.

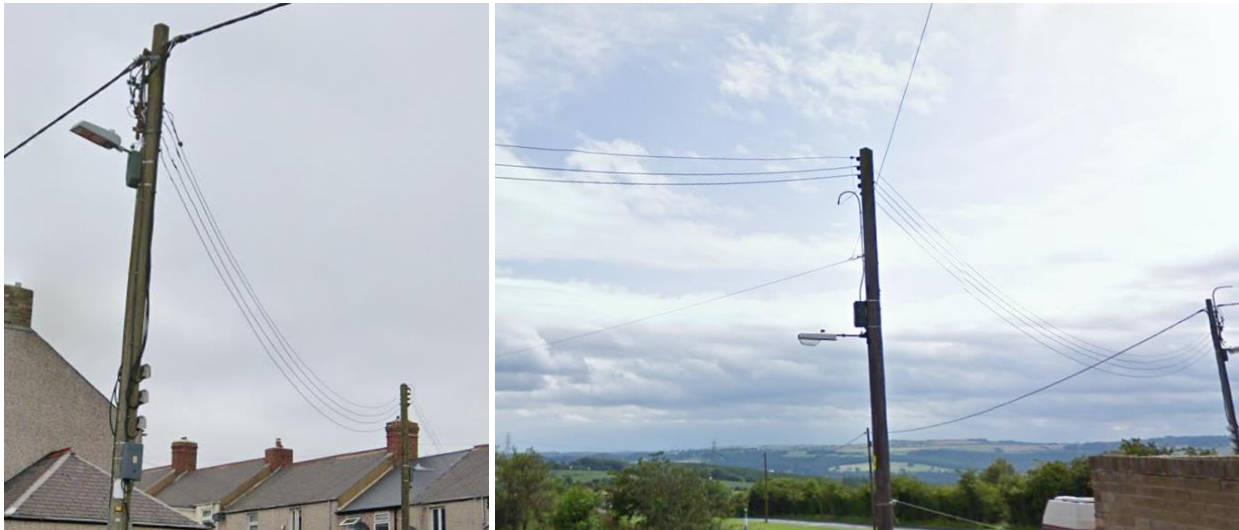
### 2<sup>nd</sup> Event Location 1: Pole 136 on Strothers Terrace

The sagging conductors visible in these images could be the cause of the PreFault event. While this waveform does not align with other suspected clashing conductor events, Storm Isha was in effect around the 22<sup>nd</sup> of January and was causing windy conditions.

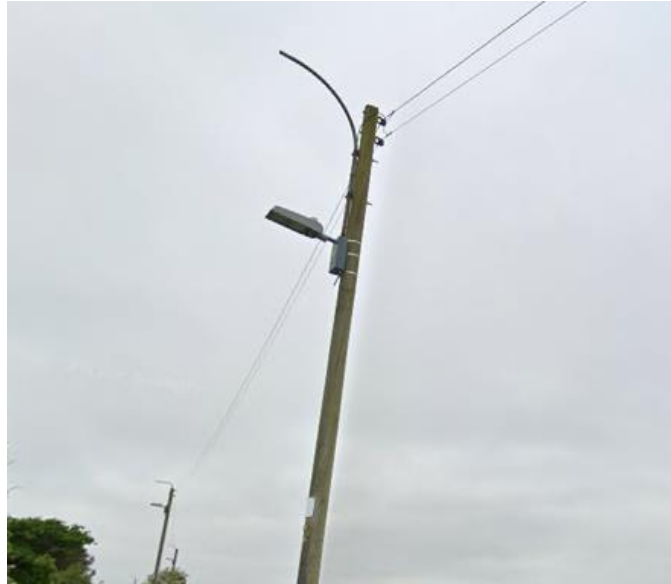
## 2<sup>nd</sup> Event Location 2: Pole 140 on Clayton Terrace

This location is in an open environment, with minimal obvious objects to interact with the line.
