# Polesight Project Final Report

Prepared for: Northern Powergrid

Report No: EA9744

Date: 22<sup>nd</sup> of March 2024

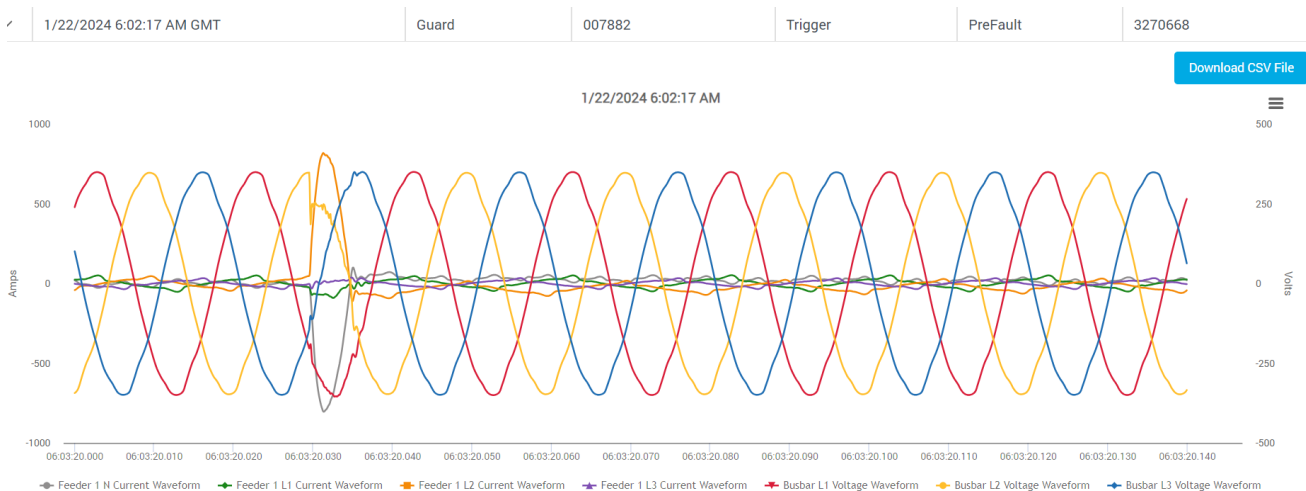
Figure 19 Polesight 04 – Townley Terrace 2<sup>nd</sup> PreFault Event

This event was locatable with the present algorithm. It had a lower peak event current than the first PreFault recorded on this feeder and the event occurred on a different phase. Although the voltage disturbances bear resemblance to the previous PreFault seen at this substation, this event has a larger effect on the other phases.

These factors suggest that this event is different from the one previously recorded, so a location check was undertaken.

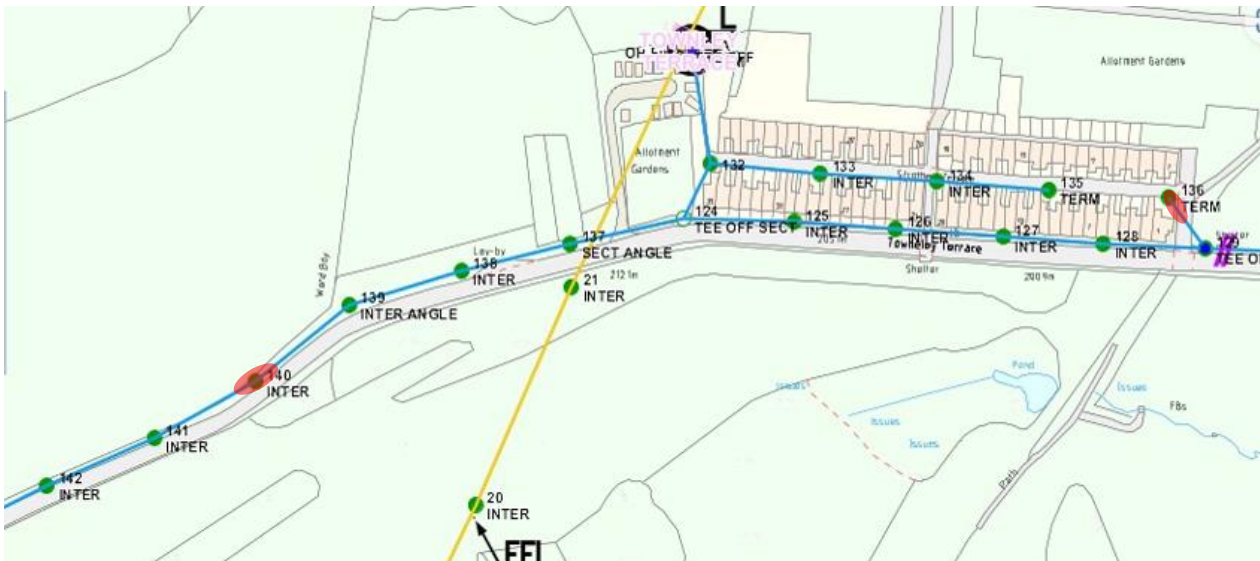
Figure 20 Polesight 04 – Townley Terrace 2<sup>nd</sup> event identified PreFault locations

It is likely that this event is not the same event as the 1<sup>st</sup> event located. In both cases, an outage or some other customer impact would have had to be reported to support the generation of any further hypotheses.

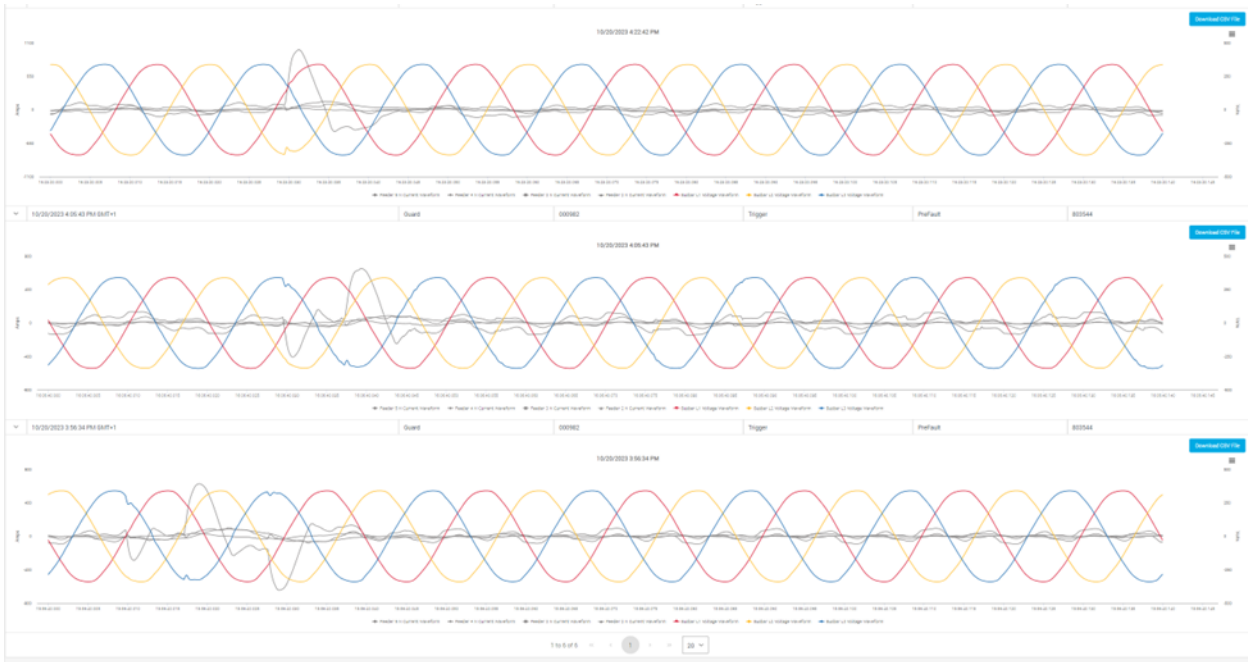
Figure 21 Screenshot of events captured on the 20<sup>th</sup> of October 2023, Brickgarth Way 4.

There were 3 events detected (Figure 21) on 20<sup>th</sup> October 2023. All were on Way 4 P64, determined from the neutral current and all were classified as PreFaults. The first two, at 15:36:34 and at 16:05:43, were blue phase to neutral events with peak current less than 700A. The third event, recorded at 16:22:42, was a L2 phase to neutral event with peak current of 985A.

All these events have much lower peak neutral current than is typically seen from a cable fault.

It is possible that the Guard at Brickgarth recorded a fault event at 16:22:42 however if this was a fault then OHL fault currents are much lower than cable fault currents. It is likely that that the  $I^2T$  of this event is insufficient to blow a 400A fuse.

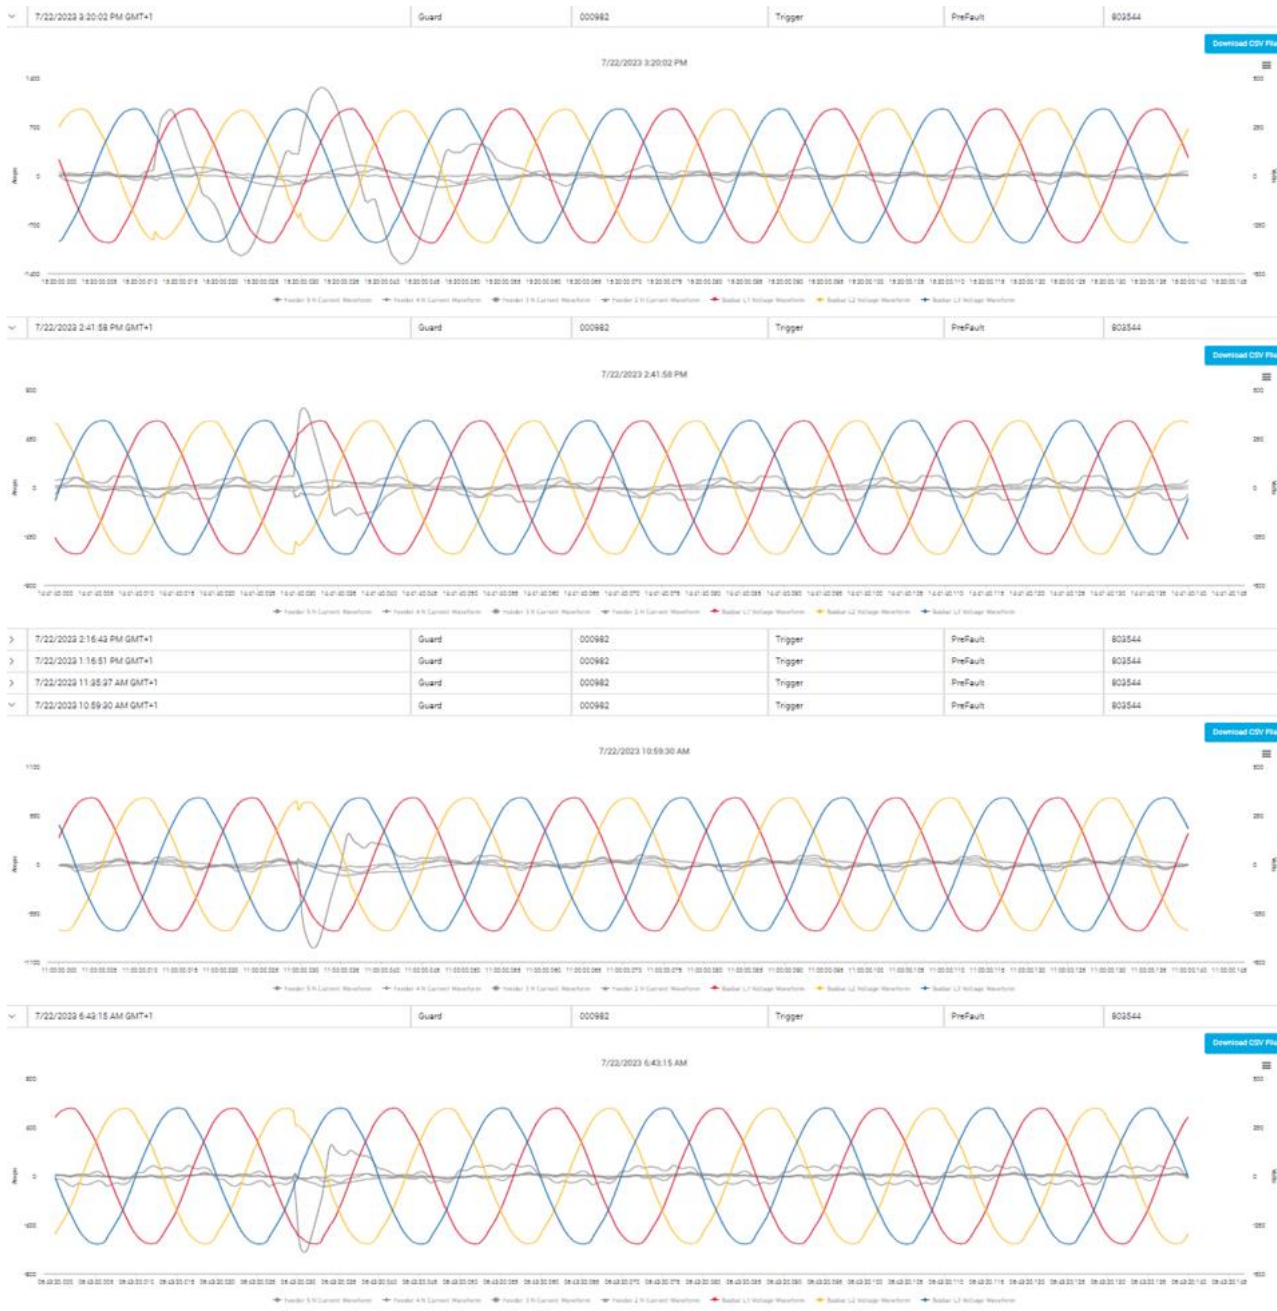
Figure 22 Screenshot of the most pertinent of the seven events captured on the 22<sup>nd</sup> of July 2023, Brickgarth Way 4.

There was an O/H service repair at 9 & 10 Girvan Terrace on the 22<sup>nd</sup> of July 2023. Seven PreFault events were captured from Brickgarth Way P 64 on the day of the fault. The last event is probably the fault event and had a peak neutral current of 1,265A which continued for three cycles. The first event was 8hr 37m before the loss of customer supply.

It seems that a developing fault was detected in an OHL service connection, which faulted at 15:20:02 on 22<sup>nd</sup> July 2023, and was reported by the customer at 16:45pm. All the captured events, including the fault, were categorised by the algorithms as PreFaults. The fault type was reported as “X2 FAULTY NECK ENDS REPAIRED, POWER OFF AT 1645, POWER RESTORED AT 1725”.

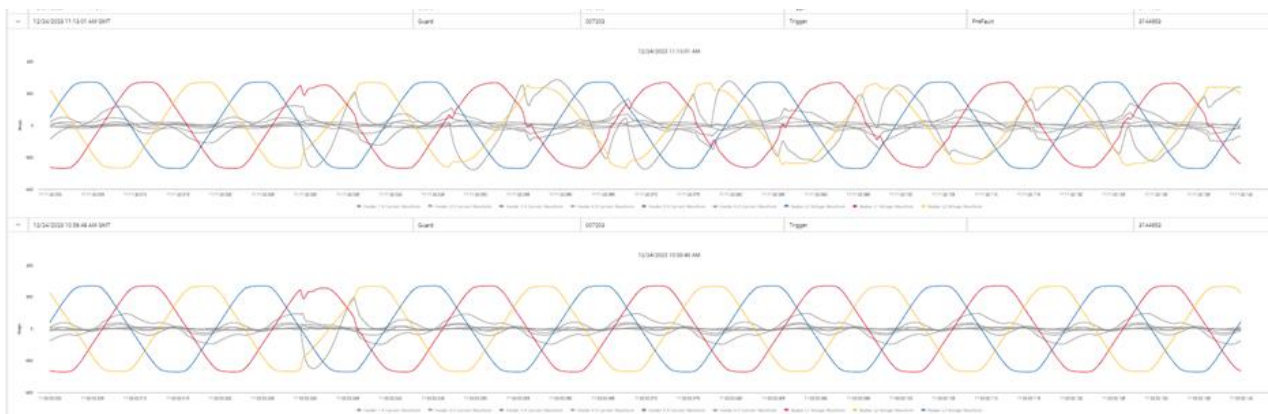
**Figure 23** Screenshot of the event captured before the O/H mains fault at Maria Pit and the top event believed to be the fault

The O/H mains fault was caused by vegetation shorting out L2 phase.

The waveform shows a clear extended repeating breakdown on sequential half cycles, between L2 Phase, L1 Phase and Neutral of feeder 4. The event extends beyond the end of the capture, which is indicative of an extended arc breakdown.

There were 30 events categorised as single-phase PreFaults and 79 events categorised as multi-phase PreFaults recorded on Feeder 4 from September 2023 to January 2024. The output of the PreFault event trending dashboard can be found in Section 5.5. There were also a similar number of events, similar to the event at 10:58:48 on 24<sup>th</sup> December 2023, that were not categorised as PreFault but by eye clearly indicate a developing fault. These mainly involving L1 and L2 phases, but also some involve the L3 phase. It is possible that the L3 phase events relate to another developing fault in this feeder.

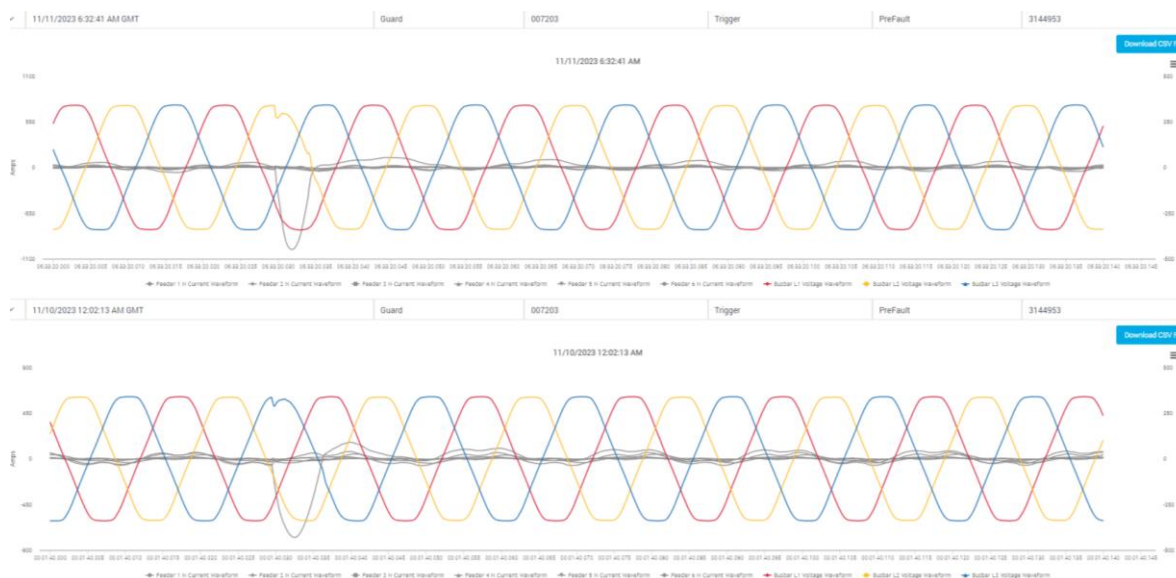
Figure 24 Screenshot of the events captured before the O/H service fault at Maria Pitt

The O/H Service Repair fault was caused by a failed Vulcanised Insulated Rubber (VIR) neck end supplying 1 & 2 Oak Street. It is possible that the L3 phase to neutral event on Feeder 4 captured on the 10<sup>th</sup> of November 2023 at 00:02:13 was the fault causing supply loss reported at 11<sup>th</sup> of November 06:36:00. There were previous L3/neutral PreFault events recorded.

There were previous L3/neutral PreFault events recorded, plus some including L2 phase in addition to L3 phase. Some Y-B-N events were not categorised as PreFault but are clearly a developing fault.

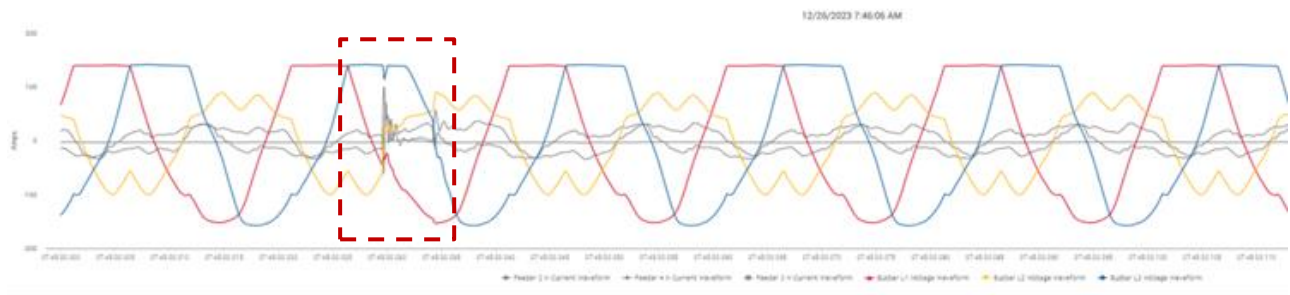
**Figure 25** Screenshot of the events captured before the bird strike (in box) incident at Warhill

A customer stated, “[he] saw a pheasant fly into the LV OH Line outside his house @0730/45 and all the lines were bouncing about and flashing”. The line taps were burnt off.

The waveform shows a three-phase plus neutral discharge on Way 2. This discharge triggered the capture but it was not categorised as a PreFault. The captured waveform is shown below.

The capture shows an unusual voltage waveform. The L1 and L3 phases show clipping on the positive half cycle plus notching on the negative half cycle. The L2 phase is more symmetrical with features that coincide with the points at which the L1 and L3 phases become non-sinusoidal, plus significant harmonics. However, this voltage waveform is seen in every event capture from the substation which has been manually checked visually, including the very first capture on 1<sup>st</sup> of March 2023.

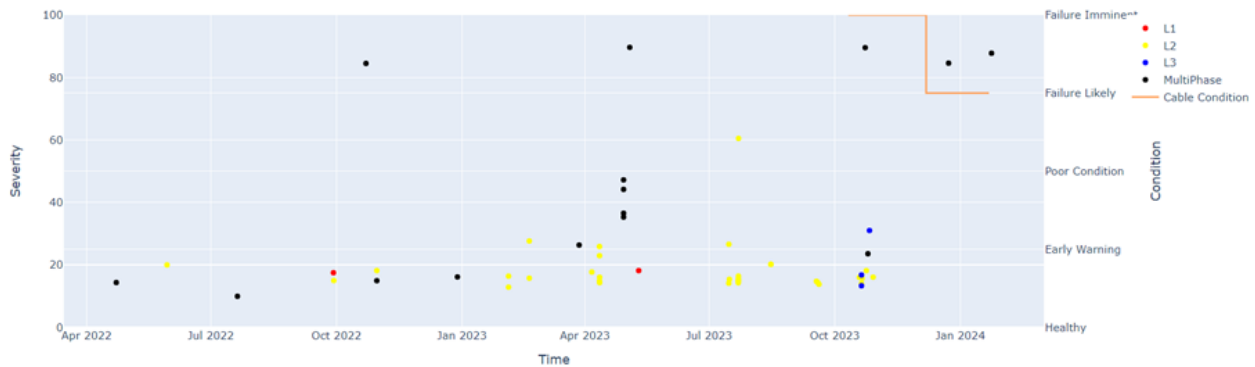
Figure 26 Chart of Brickgarth Way 4 events categorised as PreFaults

The L2 PreFault events that were detected all have a severity between 13 and 27, with the exception of one event with a severity of 60. These appear to be mainly clustered into five groups each occurring within a period of several days. There are relatively long durations between these clusters, with an occasional solitary event. It is possible that this pattern is weather-related.

Events were identified as likely to be the faults which resulted in one O/H Mains repair and two O/H Service repairs.

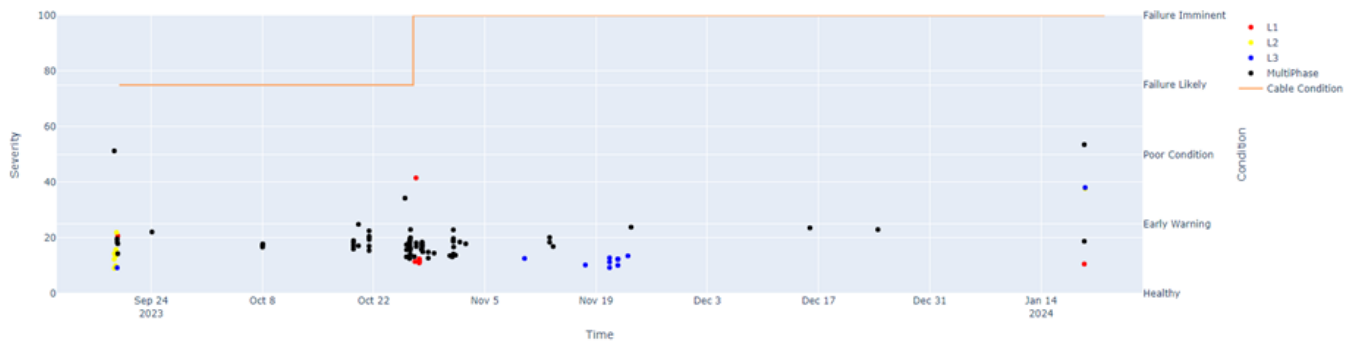
Figure 27 Chart of Maria Pit Way 4 events categorised as PreFaults

Between September 2023 and January 2024 there were 30 single phase PreFaults recorded on Maria Pit Way 4 P64, of which 9 were L1 to neutral, 10 were L2 to neutral, 11 were L3 to neutral, plus there were 79 multiphase PreFaults.

There was one O/H service repair reported on 11<sup>th</sup> November and one O/H Mains repair incident reported on 24<sup>th</sup> December on Maria Pit Way 4.

The O/H service fault was due to a failed VIR neck end. It is possible that the L3 (to neutral) event on feeder 4 captured on the 10<sup>th</sup> of November 00:02:13 was the fault causing supply loss reported on the 13<sup>th</sup> of November at 18:36:00. However, there were a cluster of L3 events captured between 17<sup>th</sup> November and 23<sup>rd</sup> November, plus a more severe L3 event was captured on 19<sup>th</sup> January 2024. Therefore, there is a gestating L3 fault which has not yet occurred. The event, which was captured on 10<sup>th</sup> November, was over 24 hours before the fault was reported, therefore it is more probable that this event is a pre-cursor of a fault that has not yet occurred.

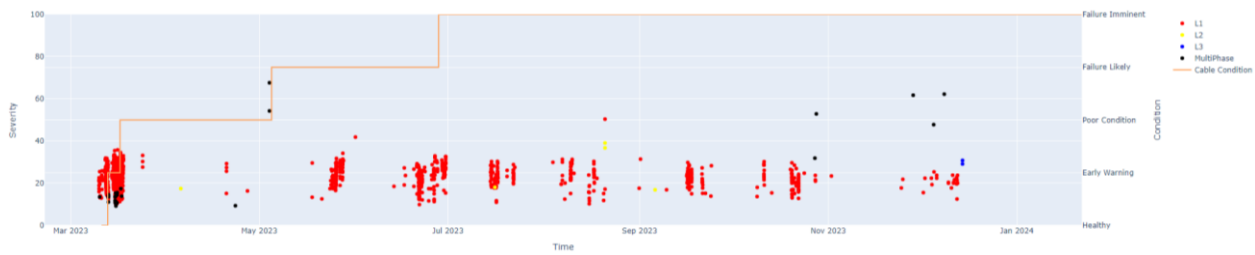
Figure 28 Chart of Elemore Lane Way 6 event categorised as PreFaults

Between March 2023 and January 2024 there were 1392 single phase PreFaults recorded on Elemore Lane Way 6 P.49 ELEMORE LANE & P15 THAMES ST, of which 1385 were L1 (to neutral), 5 were L2 (to neutral), 2 were L3 (to neutral), plus there were 31 multiphase PreFaults. The last L1 event was recorded on the 12<sup>th</sup> of December. There were two L3 PreFault events recorded on 14<sup>th</sup> of December 2023 but nothing since then.

There was an O/H Mains fault on the 12<sup>th</sup> of December caused by tail burning on an ABC box. The discharging within the ABC box, which led to the burning that resulted in a supply loss incident, is very clear from the Event Tracking Chart. There were 1385 individual L1 PreFault events recorded between the 10<sup>th</sup> of March 2023 and the 12<sup>th</sup> of December 2023.

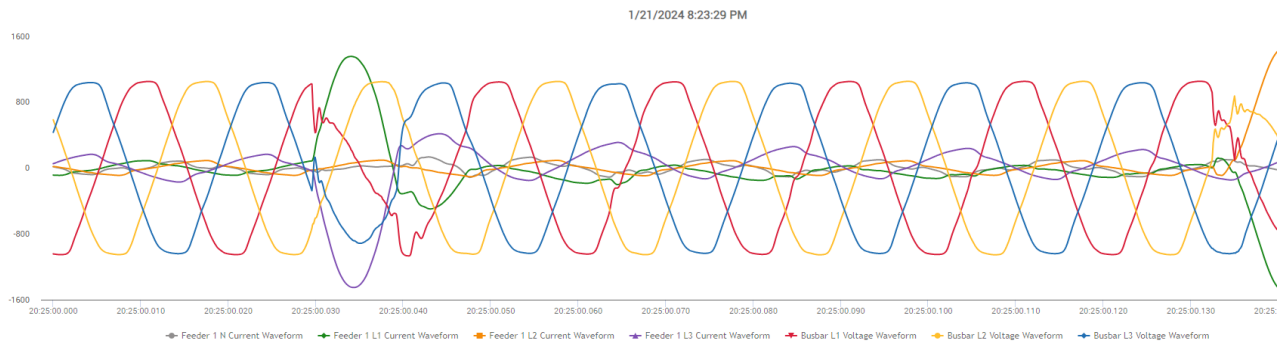
Figure 29 Polesight 07 (Syntax) PreFault event

The recorded event occurred primarily on the L1 and L3 phases of the feeder, indicating there was likely an interface between the two phases. The PreFault detection algorithm defined this event as a PreFault. This is the algorithm developed for cable faults and, should the location of the event determined be correct, will provide evidence that PreFaults seen on OHL networks can manifest similarly to underground cable networks.

There was another event that was cut off by this waveform capture which looks to show a larger current event. Unfortunately, the triggering settings for the Guard have a “lock-out” criteria, which is meant to ensure the device is not flooded unnecessarily with events if something faults continuously. The second event looks to occur on the L1 and L2 phases, different from the first event. This could suggest that the phases are coming into contact with each other, which would suggest bare wires.

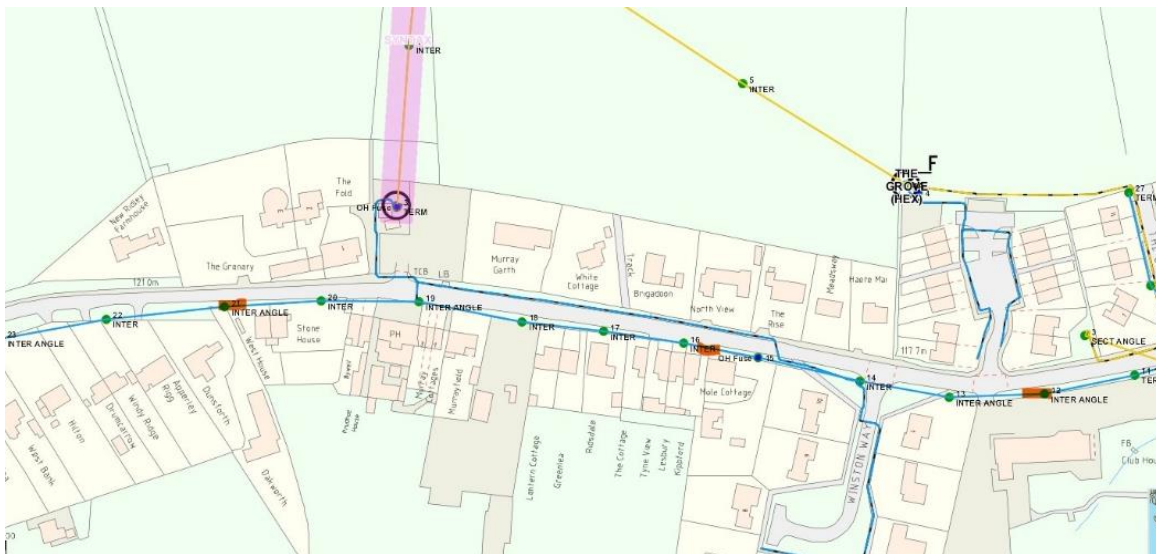
Figure 30 Polesight 07 (Syntax) Fault Locations

All three locations determined were close to poles. If this PreFault develops to a fault, or there is evidence of damage from a PreFault around the poles, it will be a good case study for what OHL PreFaults look like and allow for the opportunity to begin categorizing them.

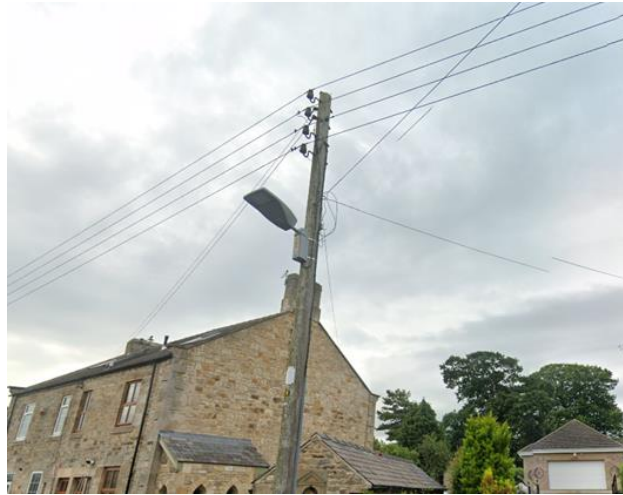
Figure 31 Location 1 – Pole outside West House

In this location, the PreFault could have occurred on an LV service or around the pole itself.

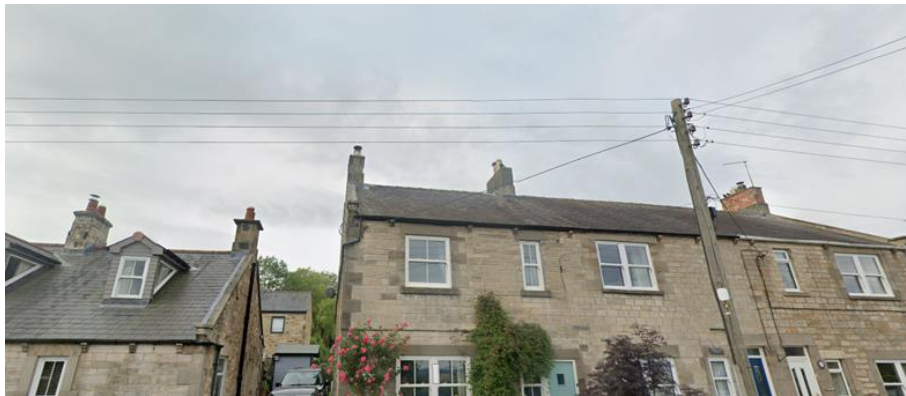
Figure 32 Location 2 – Poles near Mole Cottage

As with the previous location, the PreFault could have occurred on an LV service or on, or near, the pole.

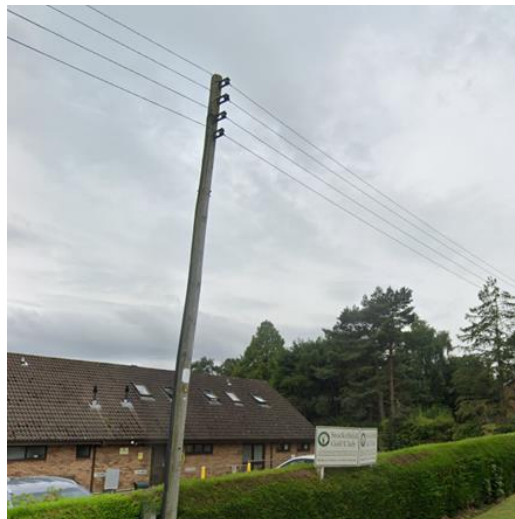
Figure 33 Location 3 – Pole outside Stocksfield Golf Club

From an initial observation this location seems like the least likely. However, as Storm Isha was in effect at the time of the event there is the chance that something may have interacted with the OHL.

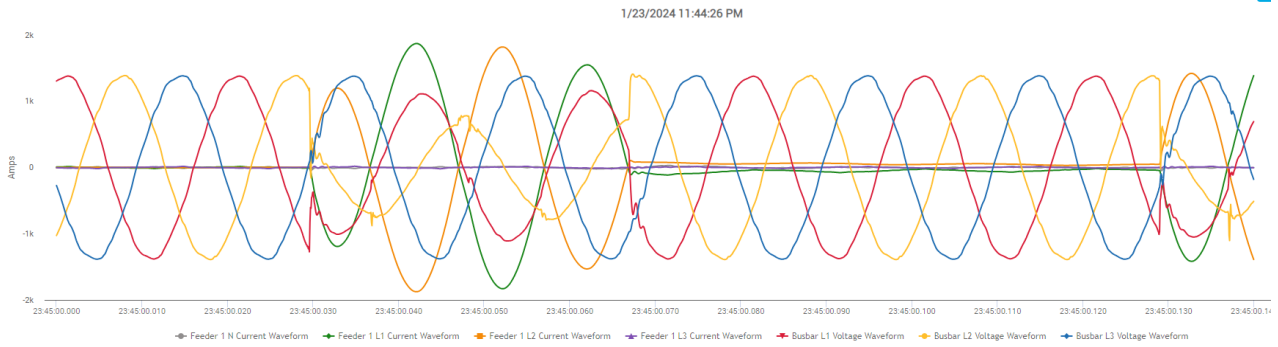
Figure 35 Polesight 10 (Summerrods) PreFault Event

The recorded event occurred primarily on the L1 and L2 phases of the feeder, indicating there was likely an interface between the two phases. The PreFault detection algorithm defined this event as a PreFault. This is the algorithm developed for cable faults and, should the location of the event determined be correct, will provide evidence that PreFaults seen on OHL networks can manifest similarly to underground cable networks.

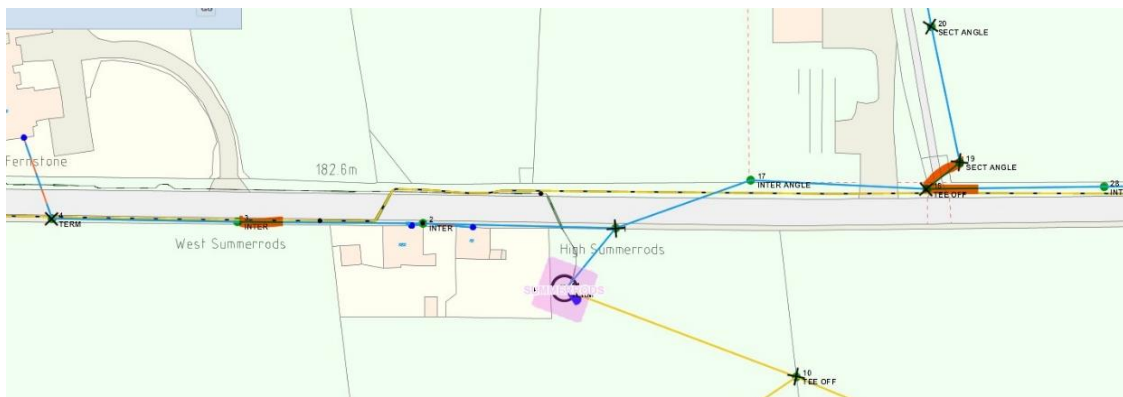
Figure 36 Polesight 10 (Summerrods) Possible Locations

All three locations determined are close to poles. If this PreFault develops to a fault, or there is evidence of damage from a PreFault around the poles, it will be a good case study for what OHL PreFaults look like and allow for the opportunity to begin categorising them.

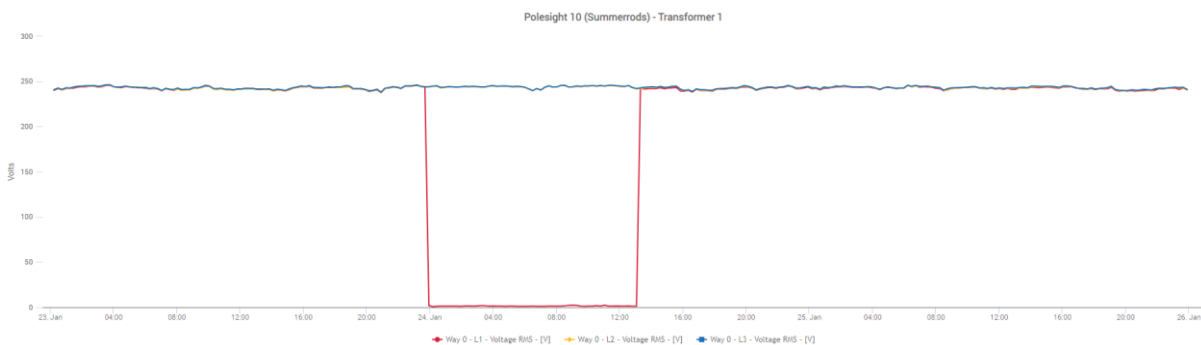
Figure 37 Polesight 10 (Summerrods) loss of L1

Using the voltage monitoring data, it is possible to develop a theory of what may have happened after the PreFault. The PreFault was recorded on phase 1 and 2 of the feeder and phase 1 seems to have lost supply soon after the event. It is likely that there was a repair or fuse replacement around 13:00 on the 24<sup>th</sup> of January as the phase was returned to service.

As there was a loss of supply, while this event is classified as a PreFault within the analytics, it is a Fault.

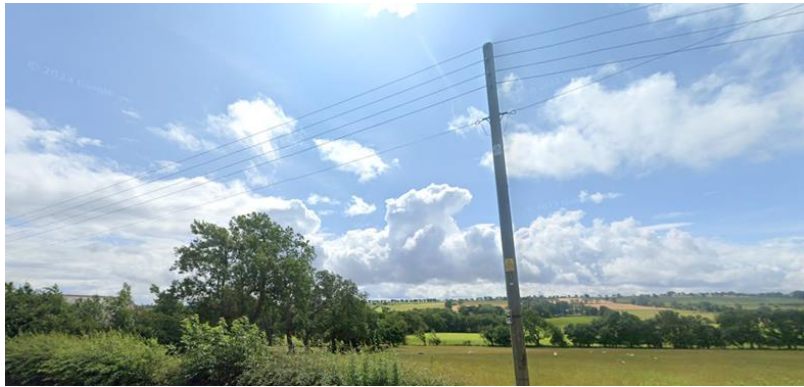
Figure 38 Location 1 – Pole opposite farm entrance

As the next two locations are close together, they have been shown in one picture. It could be that this PreFault location is on the pole where the feeder tees off.

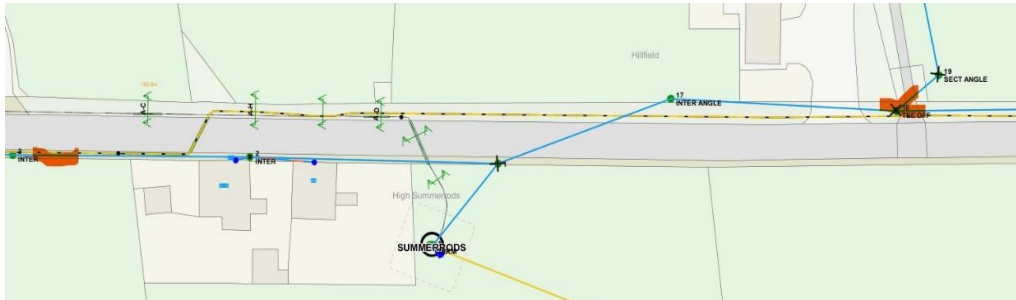
Figure 40 Polesight 10 (Summerrods) second PreFault event possible locations

A second PreFault event was recorded on the 6th of February on this feeder. This event had a credibility of 6 and was also locatable. In a positive outcome for the project, the locations match those from the first PreFault event. This suggests that the same issue that occurred previously occurred again, however this time there was no fuse blown.

The primary difference between this event and the previous event is that the affected phases are the L2 phase and the neutral phase. This causes some issues with the previous hypothesis as it is unlikely in the physical space that these two conductors would be adjacent. Whereas previously conductors for phase 1 and 2 would be assumed to be adjacent this is less likely in this event.

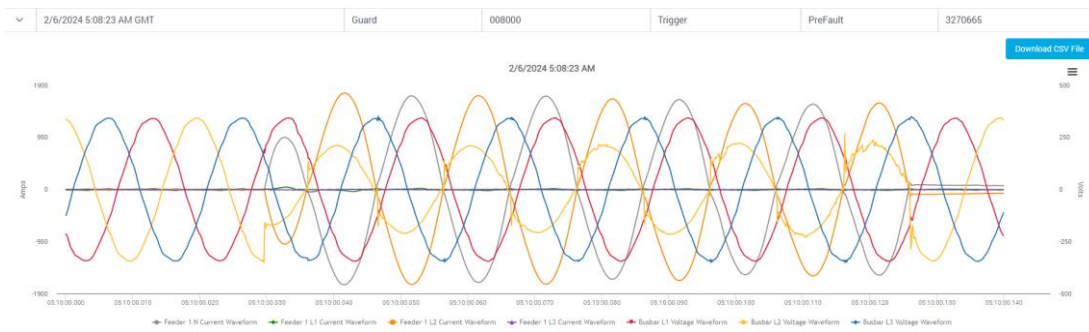
Figure 41 Polesight 10 (Summerrods) second PreFault event waveform

As there was no incident log associated with this event and no repair was required in either event there are minimal further conclusions that can be drawn from this feeder. It is most likely that the conductors are sagging, and the stormy conditions of the week caused them to clash, causing a transient fault in the first instance and a PreFault in the second. However, this is a hypothetical and not a definite conclusion.

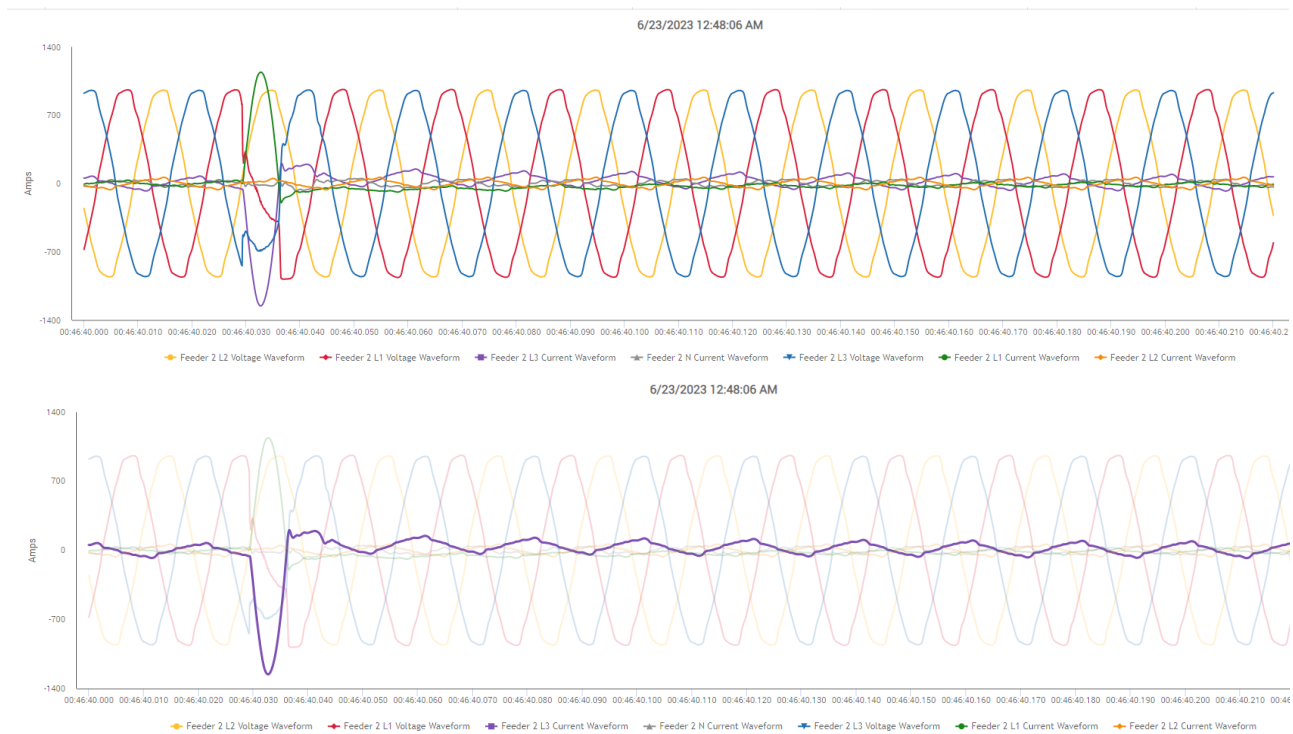
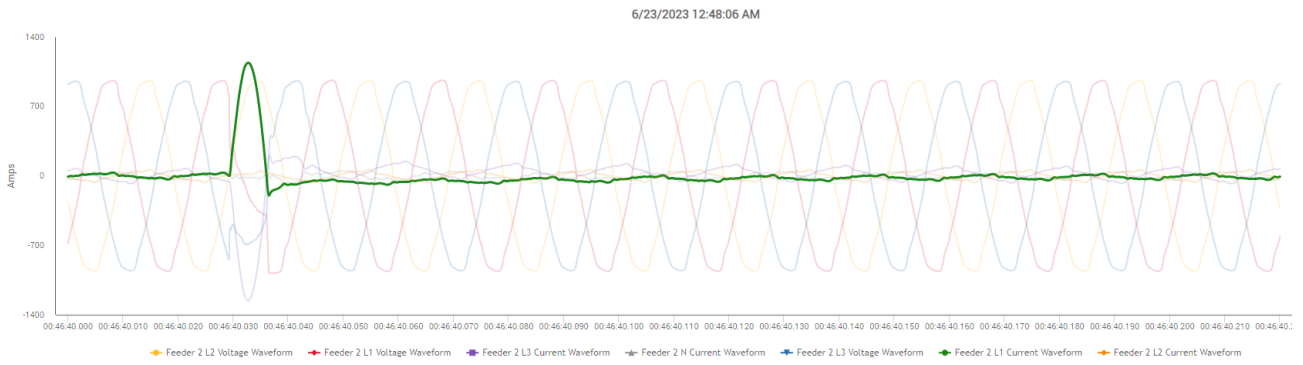
Figure 42 Polesight 14 (West Causey Hill) first PreFault event waveform

This event was categorised as a PreFault, and the 2-phase event occurred on L1 and L3.

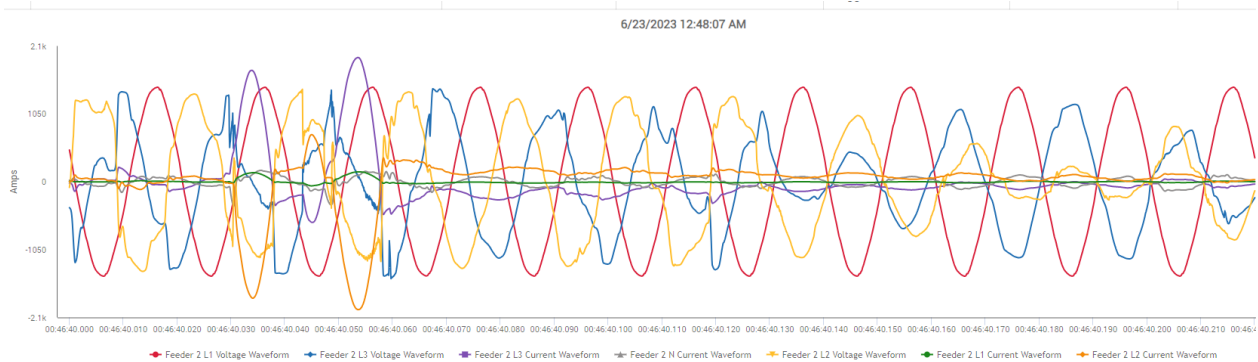
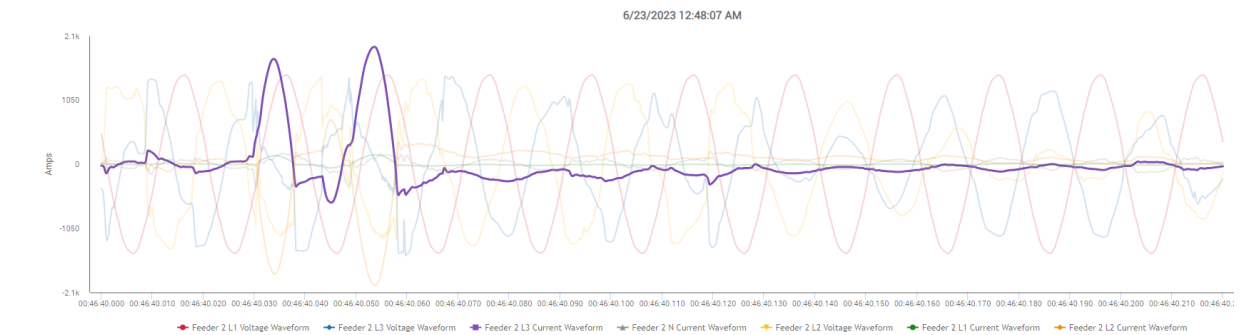
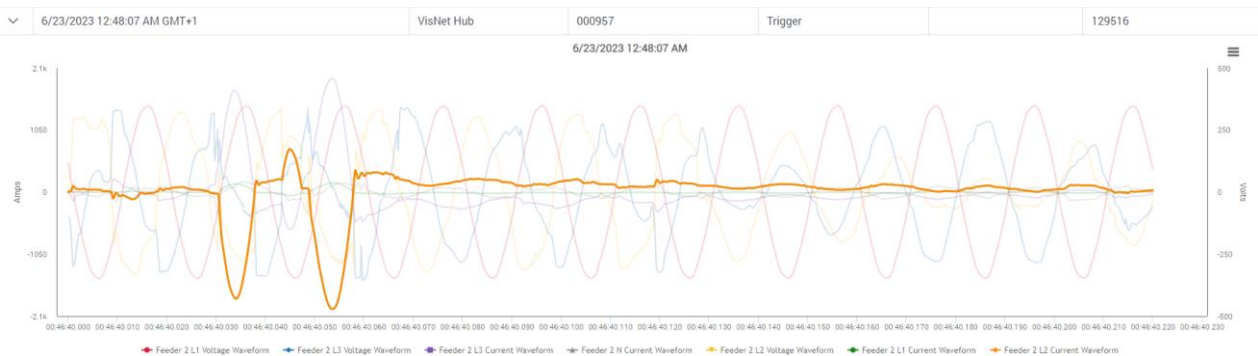
Figure 43 Polesight 14 (West Causey Hill) second event waveform

However, on the waveform for the second event the extraneous currents are on L2 and L3.

The second event was not categorised as a PreFault:

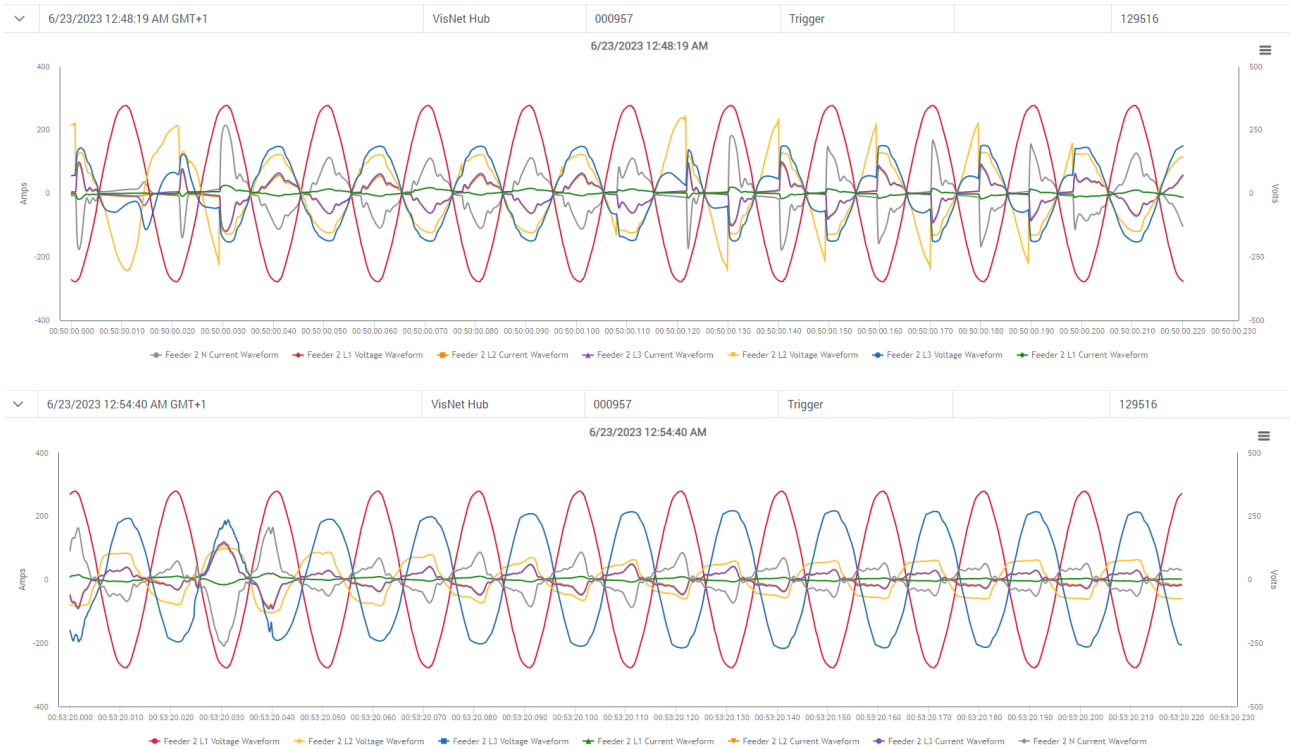
Figure 45 Example of post event, pre fix waveforms

After this second event the waveforms became more distorted and these are being compared against other waveforms to see if there's commonality with other events. It can be seen that the L1 voltage seems mostly unaffected.

The events captured following the first PreFault have generally only been recorded due to the neutral current exceeding the triggering level.

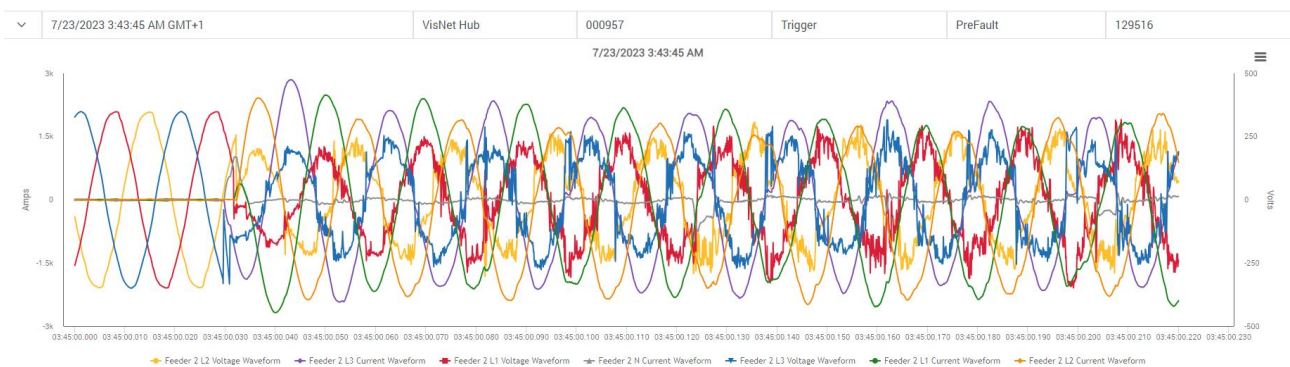
Figure 46 Polesight 14 (West Causey Hill) most credible event

Other examples of fault events within this report show events on OHL feeders. Polesight 14 provides an example of a cable fault event, which develop differently. Figure 46 shows the most credible event out of the over 400 recorded on the day of the event.

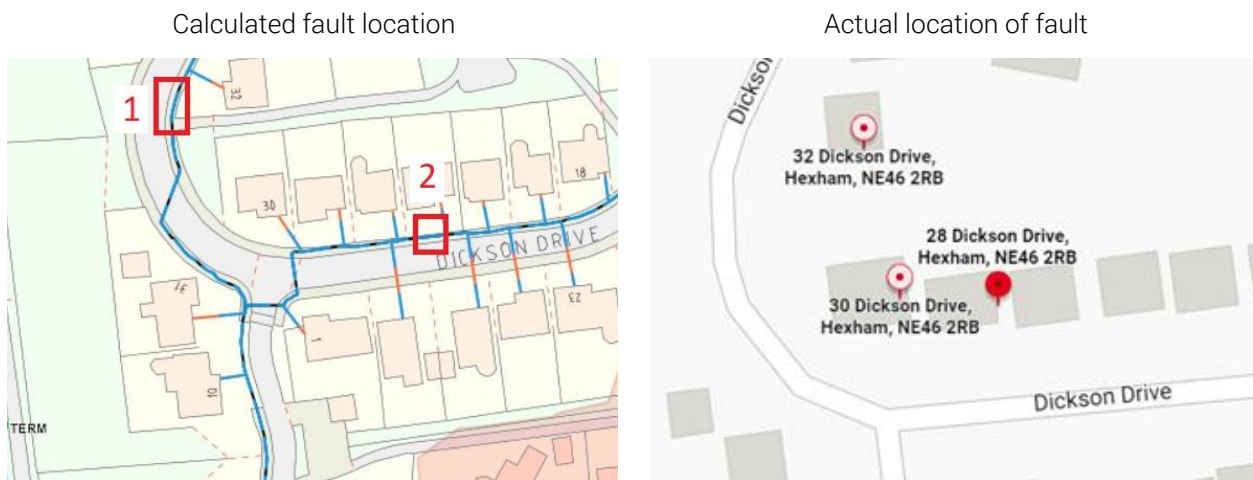
Figure 47 Comparison of calculated fault location and actual fault location

As the feeder splits in two directions before the fault, two locations were provided by the calculations (1 & 2). Margins of error occur due to the digital twin of the feeder not being an exact clone of the physical feeder, however in normal operations both paths would be investigated, and the target area provides a start point for operatives searching for the fault.

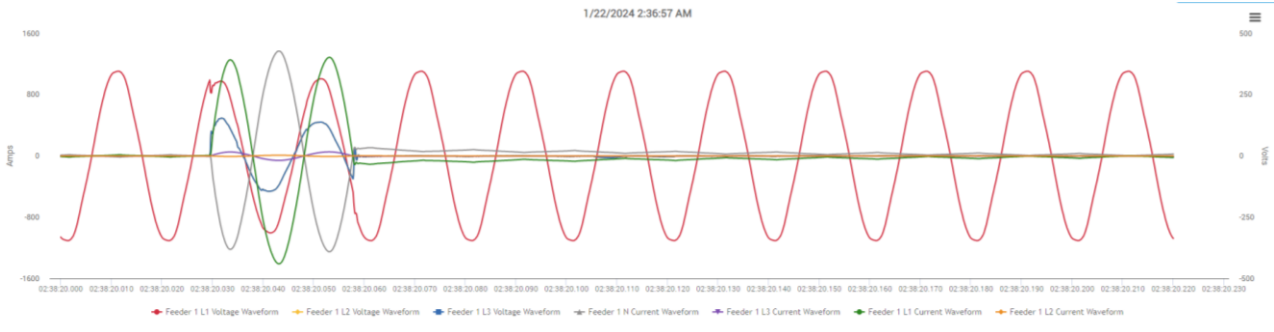
Figure 48 Polesight 18 (Mickley Junction) PreFault event waveform

The recorded event occurred primarily on the L1 phase of the feeder. The analytics defined this event as a PreFault. This is the algorithm developed for cable faults and, should the location of the event determined be correct, will provide evidence that PreFaults seen on OHL networks can manifest similarly to underground cable networks.

Mickley Junction is a split-phase feeder and in this waveform there is only one of the voltages being displayed. This could suggest that the other voltage had already been lost.

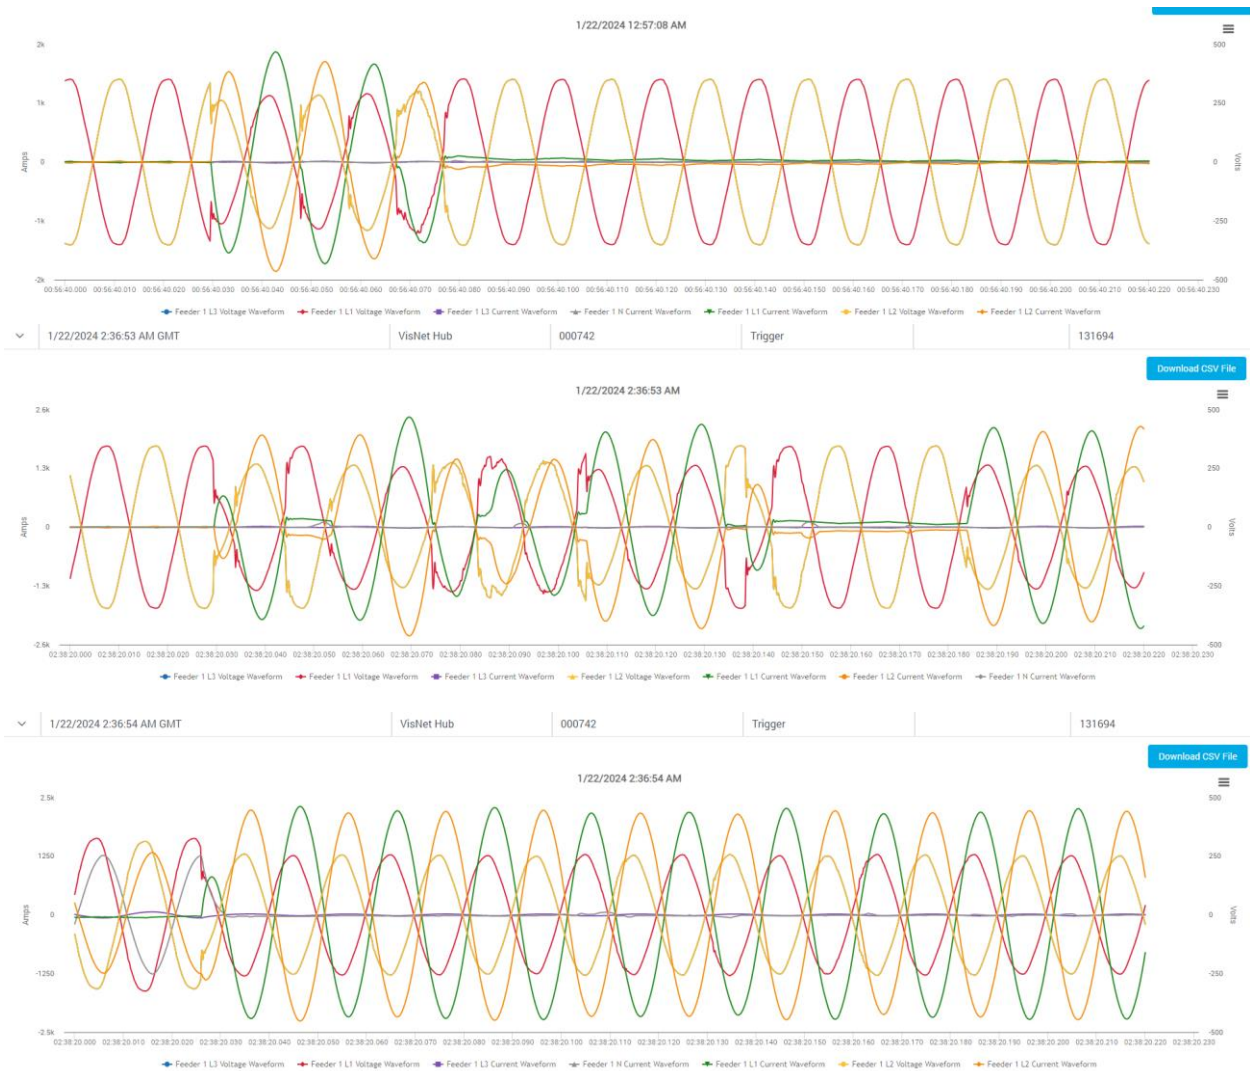
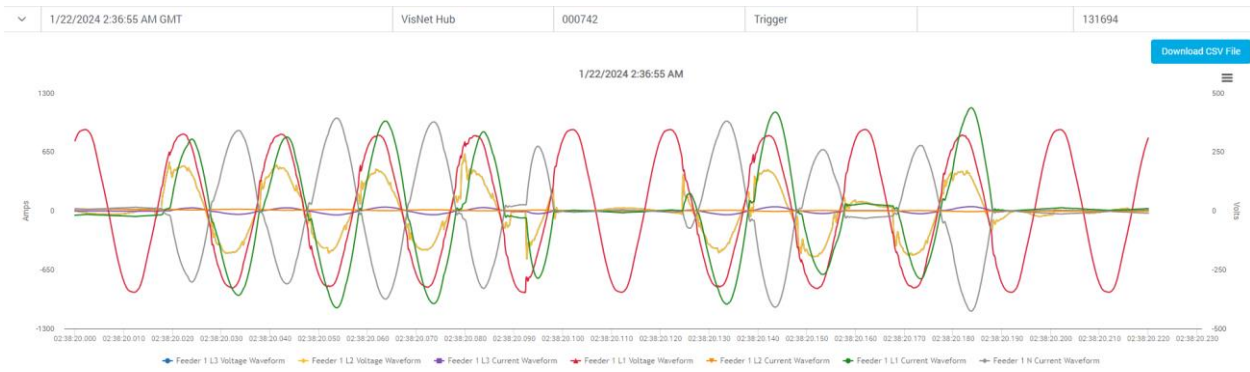
Figure 49 Polesight 18 (Mickley Junction) non-PreFault event waveforms

Only two of these events could be analysed by the Guard analytics and neither of them were recognised as PreFaults. This is consistent with other events recorded by devices monitoring split-phase transformers, where, if events are analysed at all by the Guard analytics, they are not classified as PreFaults when they are likely to be PreFaults.

The third waveform, at 02:36:54, bears resemblance to the PreFault seen by Polesight 10 where the likely cause of the PreFault was clashing conductors. As this event was not categorised as a PreFault some further investigation into how split-phase transformers are analysed may be required.

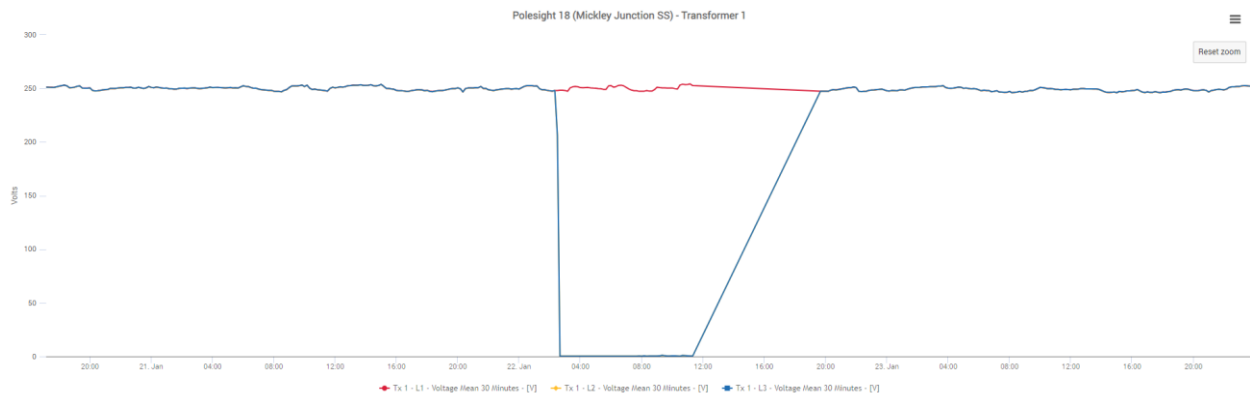
Figure 50 Polesight 18 (Mickley Junction) device voltage around the time of the event

This event seems to have blown the fuse on phase two of the feeder. The device was unresponsive for around 8 hours on the 22<sup>nd</sup> of January, between 11:20 and 20:10 so it is possible there was a repair occurring on the feeder.

This image shows phase two with no voltage and the unresponsive device at 11:20, where the diagonal blue line jumps from zero to a standard voltage.
