# Polesight Project Final Report

Prepared for: Northern Powergrid

Report No: EA9744

Date: 22<sup>nd</sup> of March 2024

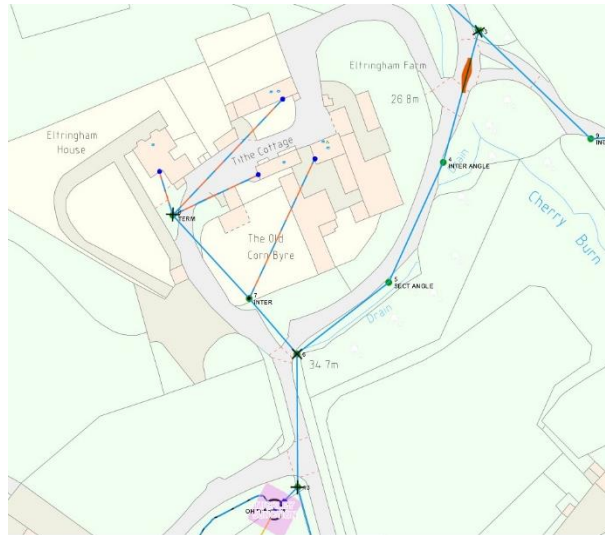
Figure 51 Location determined by impedance calculation

Using the standard algorithms for PreFault location the iSmart feeder map was marked up in red where the algorithm provided a location.

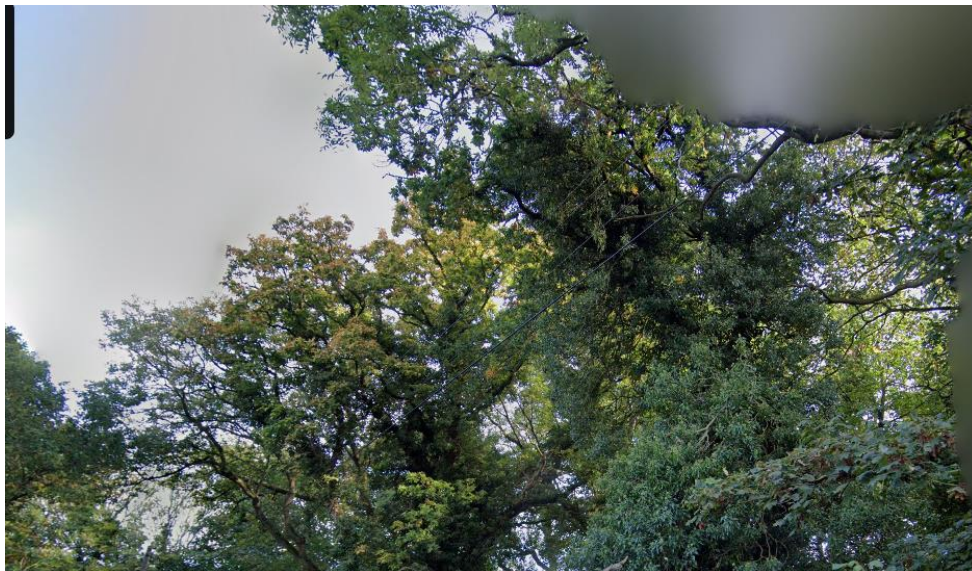
Figure 52 Location determined by impedance calculation

Only one location has been determined for this PreFault, a heavily wooded area that suggests that there could have been interaction with a tree.

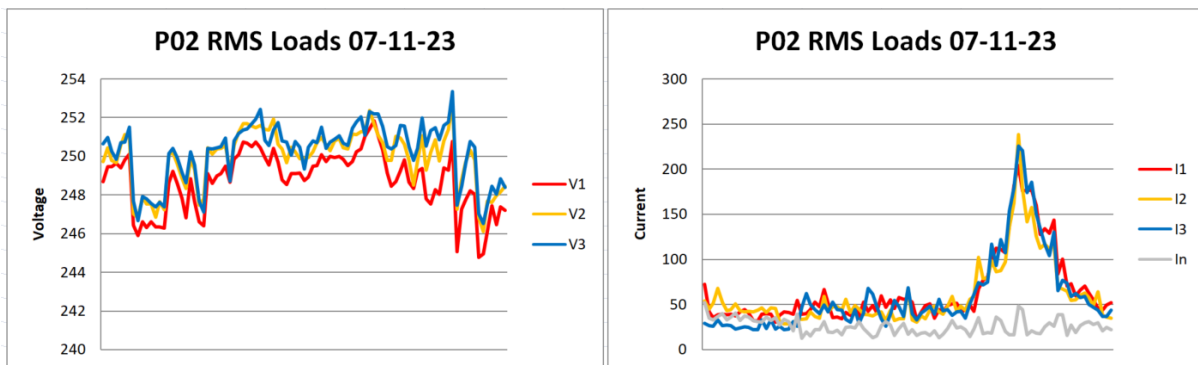
Figure 55 Example of HV Insights from Analogue Measurements, balanced load yet slightly unbalanced voltages

The below diagrams show the 24-hour analogue voltage and current profiles measured on P02, installed on the LV side of the three-phase HV/LV Pole mounted transformer at Corbridge Station in the West Wylam Primary group of substations. Although all within acceptable limits, on the voltage chart, L1 can be seen to be consistently lower than L2 and L3.

The voltage on the LV side of a transformer is a function of the HV voltage, the transforming ratio, and the load drop through the transformer. In a healthy transformer, transforming ratio should be the same in each of the phases. In this instance, it can be observed that the load delivered through the transformer is balanced between the phases. The implication therefore is that there is a slight difference in HV voltages at this point in the network. Where the voltages remain outside acceptable tolerances and these conditions persist, use of this analogue voltage insight could be used to alert operational management for possible investigation. Where there are multiple devices deployed on the same network the location, the point at which any out-of-tolerance condition arises becomes apparent.

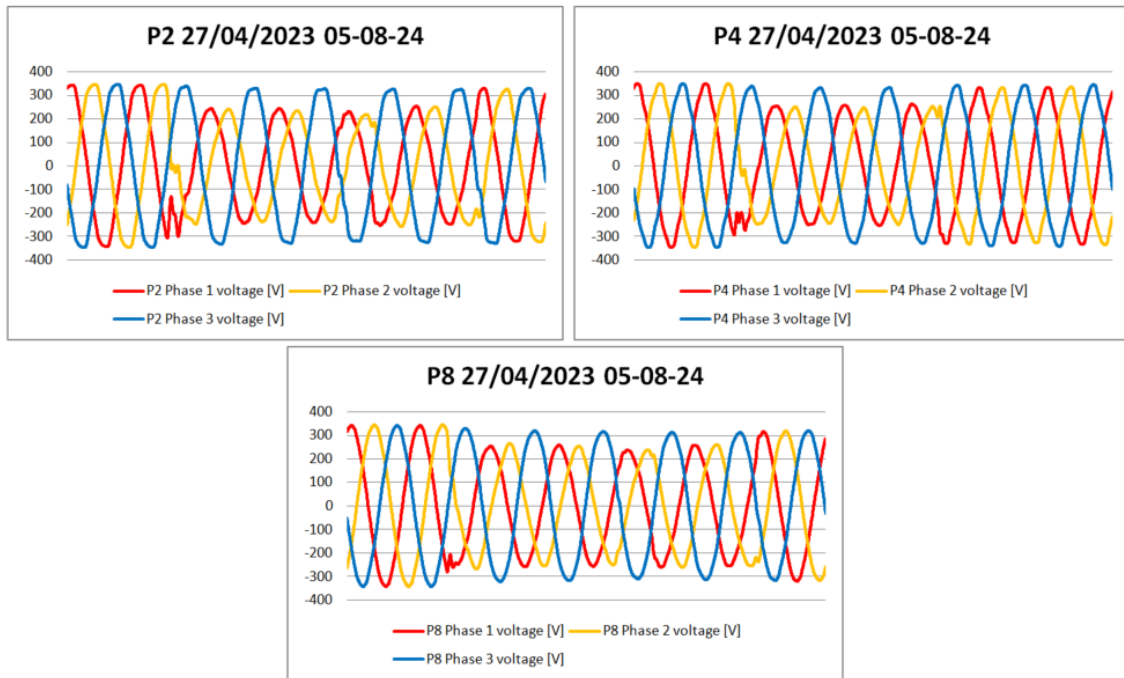
Figure 57 Example captures from devices in three of the 4 primary groups from suspected Grid event on 27/04/2023

By eye, whilst in steady state the voltage dips look similar, P2 appears to have a more vigorous reaction to the onset of the event.

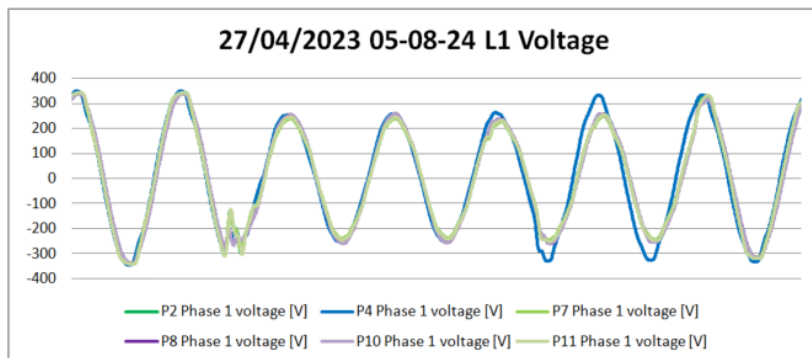
Figure 58 Voltage on LV phase L1 from each of the devices that captured the suspected Grid event on 27/04/2023

The chart appears to show that the event was seen for longer on the Hexham (P08, P10) and West Wylam group (P02, P07, P11) substations than it was on the Dunston group substation (P04). This dis-similarity may therefore give an additional clue as to the location of the event.

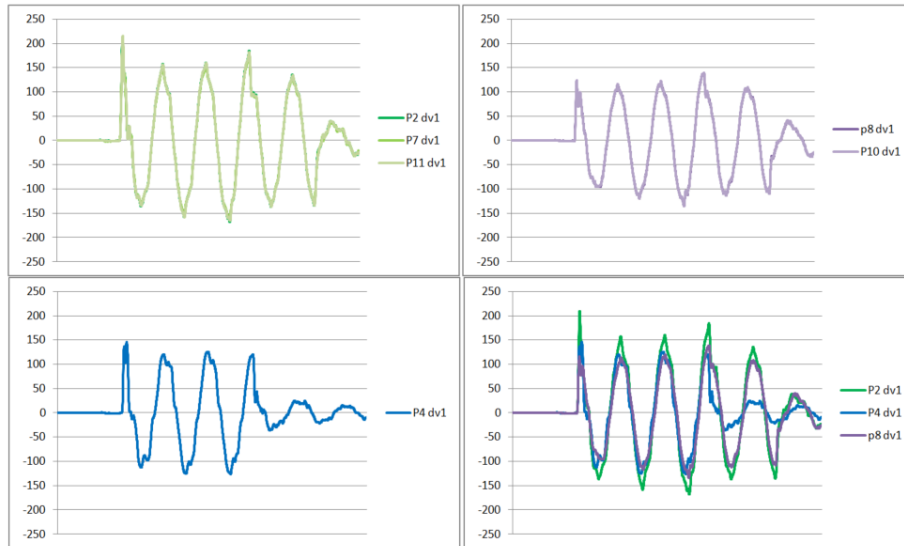
**Figure 59** Voltage difference study for the three groups that experienced the suspected Grid event on 27/04/2023 05:08:24

The additional chart in the bottom right on Figure 59 compares the difference in V1 voltage dips seen between one device in each of the groups. In this instance, the West Wylam Groups appears to have seen the largest voltage difference drawing attention to the possibility of this event being on the 132kV network feeding Coalburns. The Hexham group again appears to have less of voltage dip that the West Wylam group, again strange given that they are fed from the same Grid substation at Coalburns, but at least consistent with the previous example. The Dunston group (fed from Dunston Grid) however has a similarly large dip and appears to have had a faster protection response that clears the cause of this event more quickly than the substation fed out of Coalburns. This draws attention to the 66kV network and the fact that these two grid sites run interconnected.

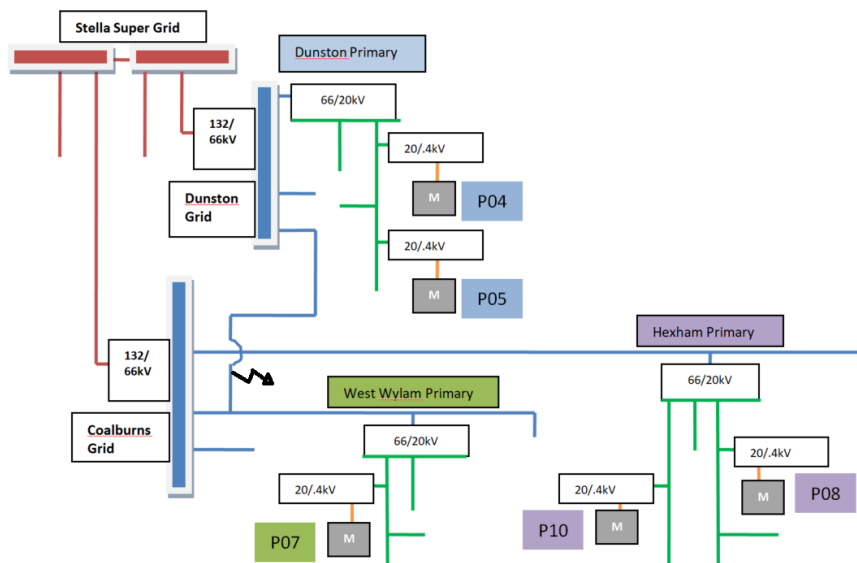
**Figure 60** Network schematic showing potential location of 27/04/2023 (low confidence)

In considering the possible location of the source of this event, the absence of capture from the Spadeadam group, it being associated with the Stella North and South Supergrid group, the interconnection at 132kV and 66kV obfuscates confidence in any further localisation. The balance of probability, because of the sharpness of response, is that this major event was actually on the 66kV network interconnecting Dunston Grid and Coalburns but there is little confidence in that assessment.

No incident report was available at the time of writing, so it is not possible to report the actual source and why the Dunston group voltage recovered more quickly than the other groups.

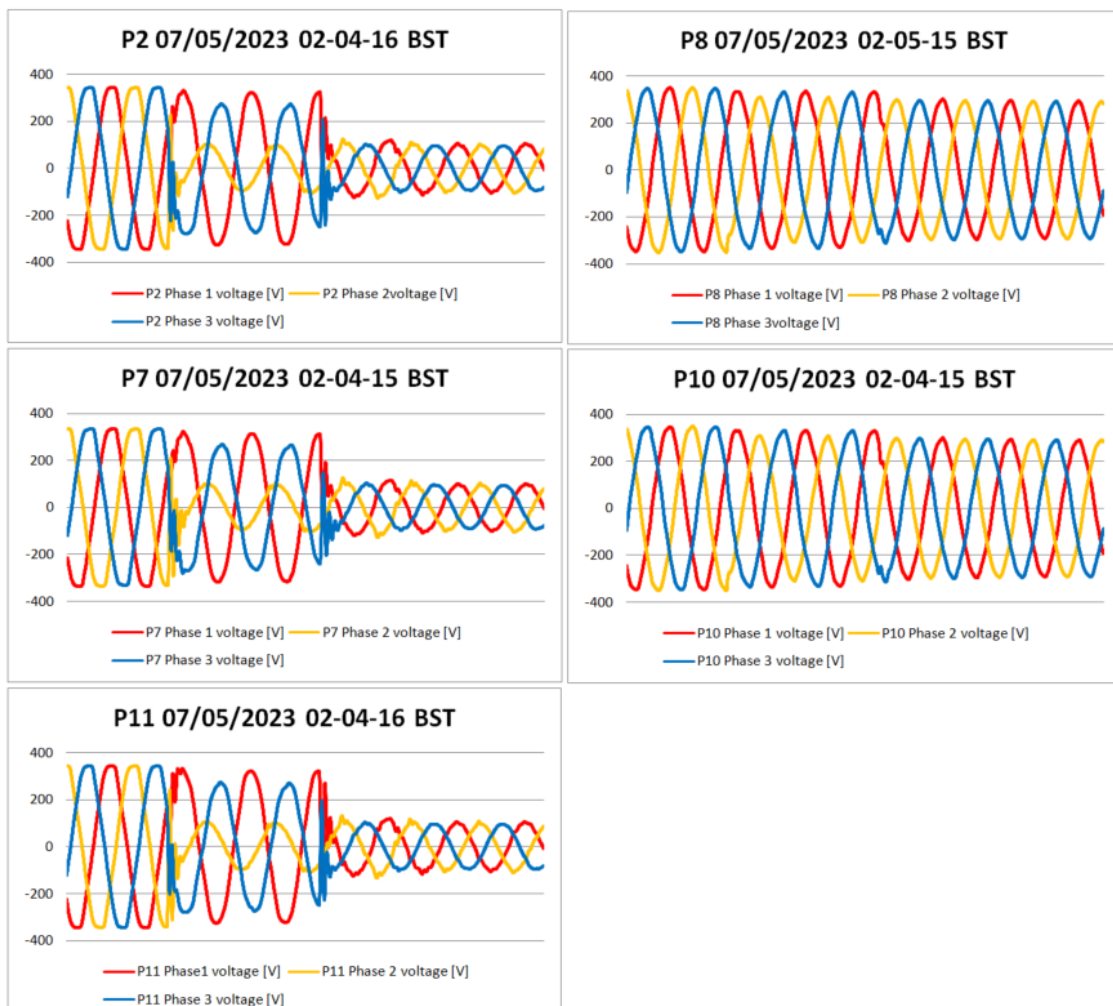
Figure 61 Captures from substations in the Wylam Group and Hexham Groups for suspected 66kV Fault on 7th May 2023

For this example (see Figure 61), the differences between the captures from the two groups involved (the West Wylam group on the left and the Hexham group on the right) are clearer than previous examples. The event has distinct characteristics, being split into two stages: the first causing a large collapse in L2 voltage, and partial collapse of L1 and L3 (as seen at LV), the second appearing as a full, balanced three-phase fault, collapsing all three phases consistently and significantly.

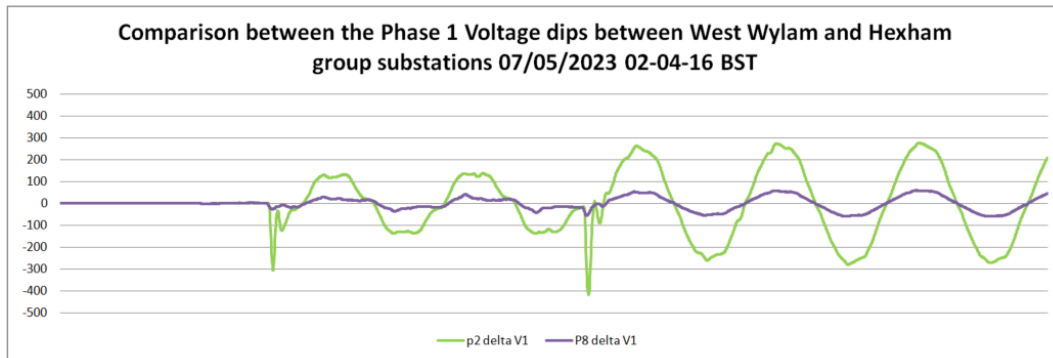
Figure 62 Difference in voltage dips for phase 1 between the captures on West Wylam Group and Hexham Group substations

Though both groups of substations are supplied from the same 66kV bars at Coalburns, Figure 62 shows how the voltage dips experienced by the West Wylam group and vigour of response to the onset of the fault are much larger than those experienced by the Hexham group.

It is considered improbable that a three-phase 66kV fault, even at the extreme end of the 66kV network would produce such a small dip on the bars at Coalburns which, unless there is significant generator support nearby, which would be also experienced by the Hexham group. The probability, therefore, is that, despite the event being picked up by substations in two adjoining groups, this fault is actually on the West Wylam Primary Substation group 20kV system. In high level analysis therefore, information on the degree of voltage dip (and potentially other event characteristics) would be needed in order to discriminate between EHV faults and HV faults reflected onto the EHV system through which they are also fed<sup>13</sup>.
